REPORT NO. 2000036.401
REVISION: 0
PROJECT NO. 2000036.00
November 2020

Examination and Analysis of Equipment Involved in Mr. Justin Moore's June 8, 2017, Fall Incident

United States District Court
Northern District of Texas
San Angelo Division

Justin Moore and Judith Moore vs DB Industries, LLC, et al.

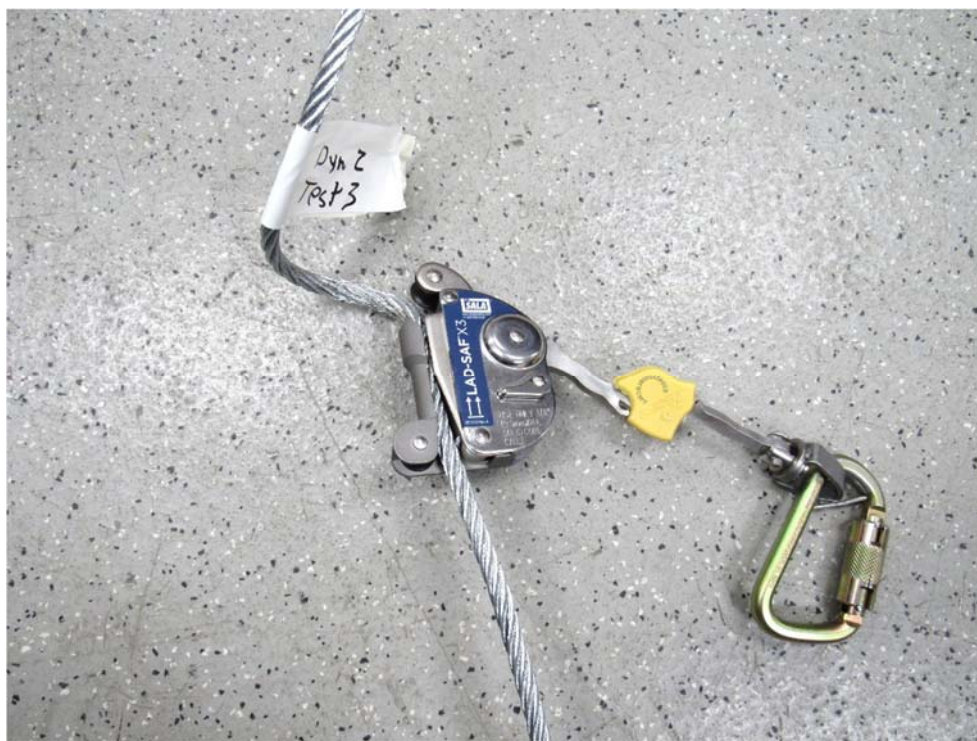
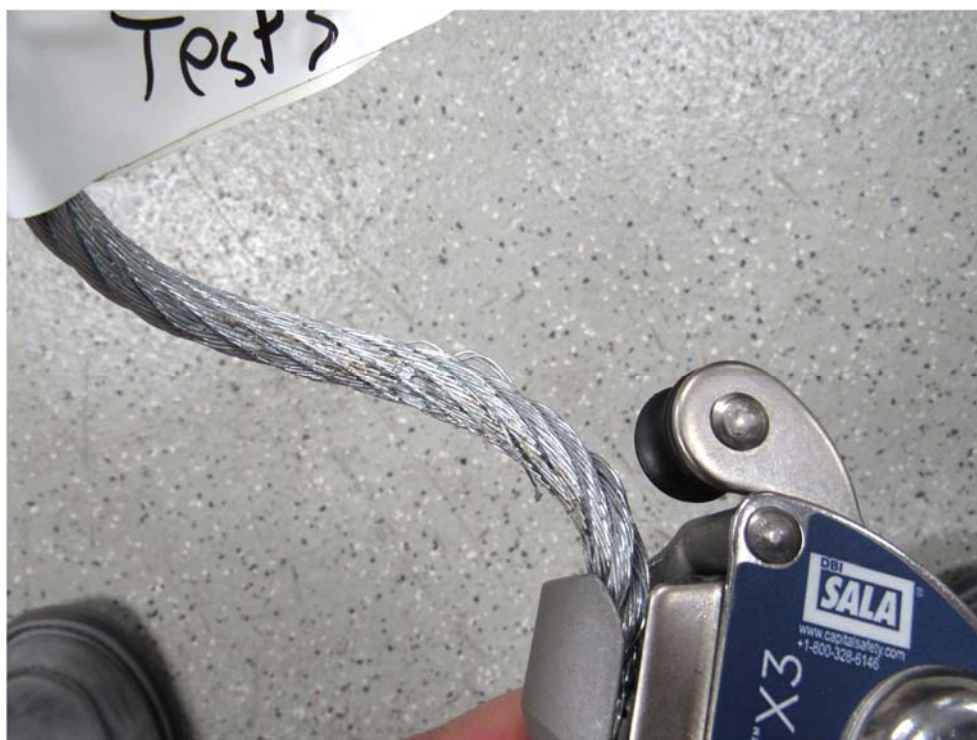
Figure 36. Additional views of the damaged cable and broken wire strands associated with the 16-1/2 foot drop test performed on October 30, 2020 (images provided by 3M).
